## 2003 – 2015 Dodge Ram Cummins 68RE & 68RFE Transmission Cooler Line T-Fitting

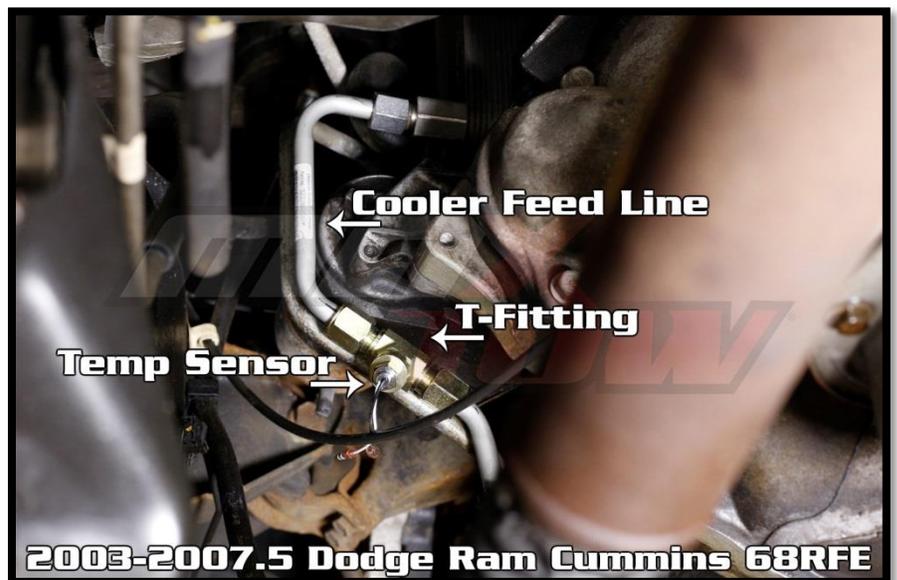
2003-2007.5 Dodge Ram Cummins 68RFE

2. Locate the cooler feed line on the passenger side of the transmission housing. **Note:** The upper line is the cooler feed line and the lower line is the return line from the cooler.
